ECOLOGICAL HULL DD TREATING REPORT

Owner: LAURITZEN KOSAN TANKERS

μ-jet system surface preparation

Ecological hull cleaning / painting during DD

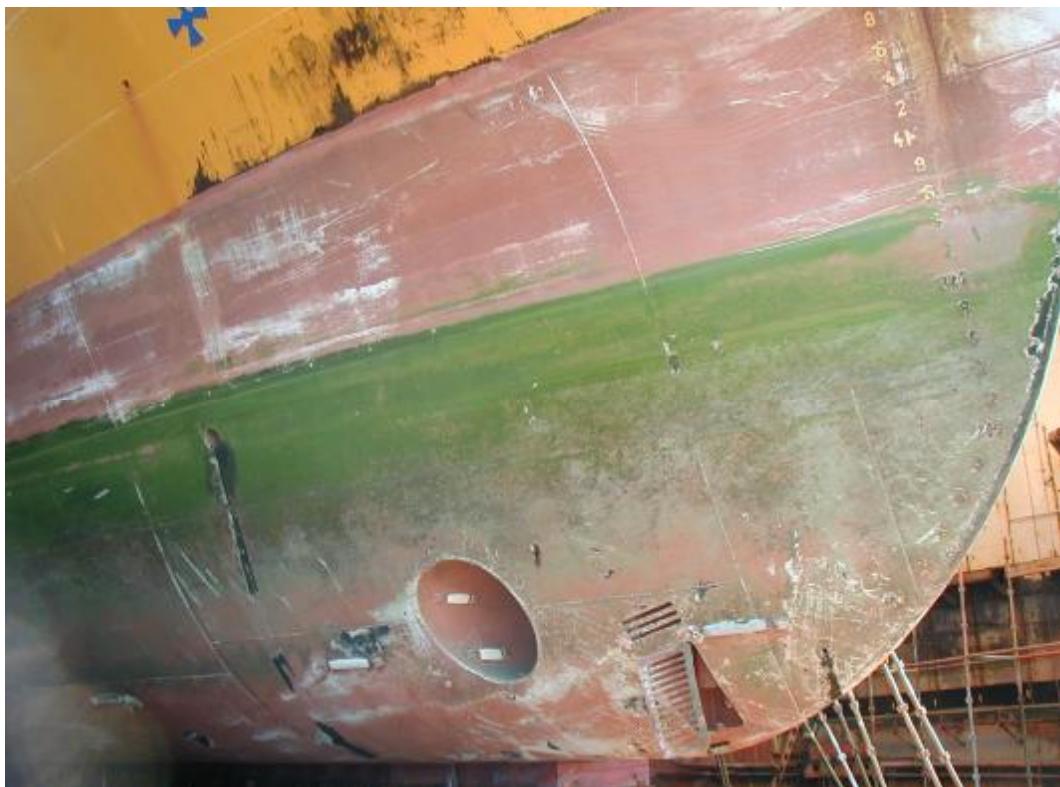
Photo 1. LAURA KOSAN – initial condition.

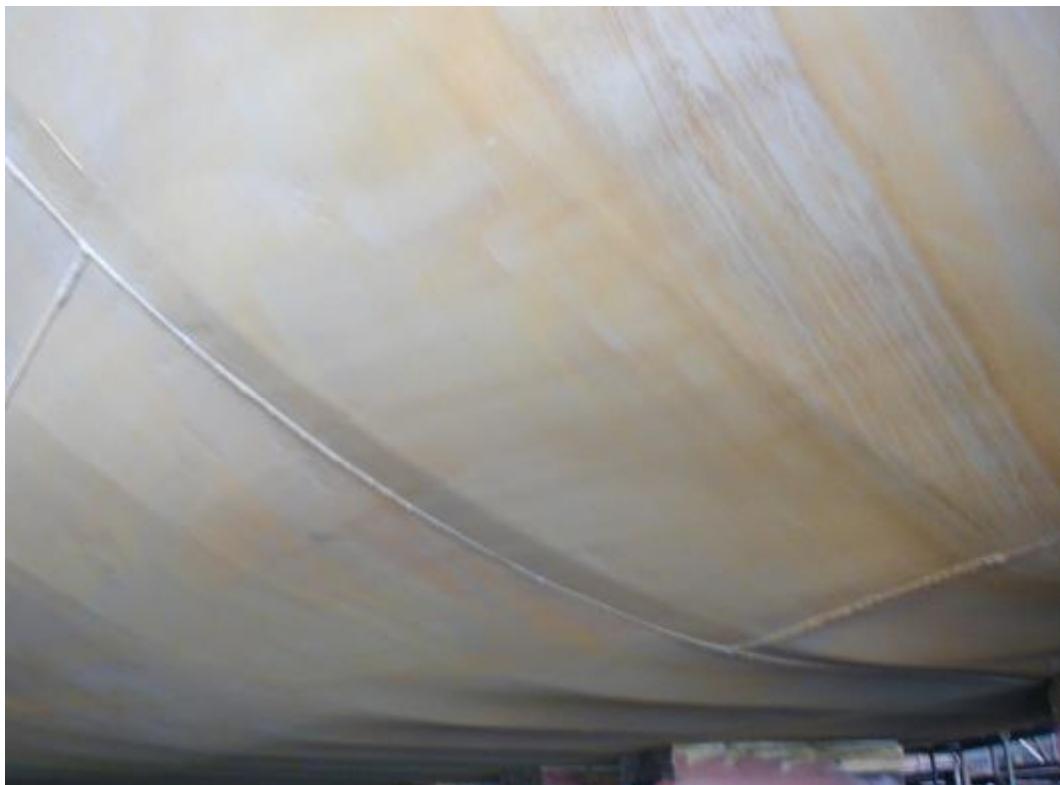
Photo 2. LAURA KOSAN underwater part – surface preparation.

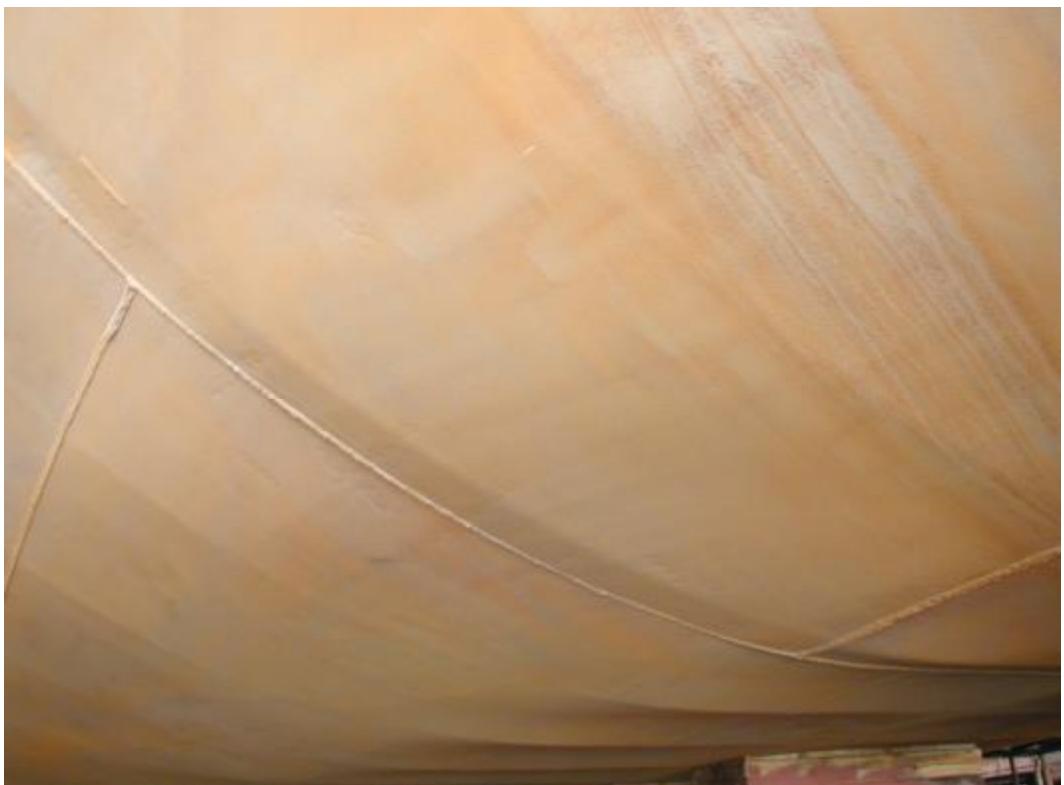
Photo 3. LAURA KOSAN underwater part – surface preparation.

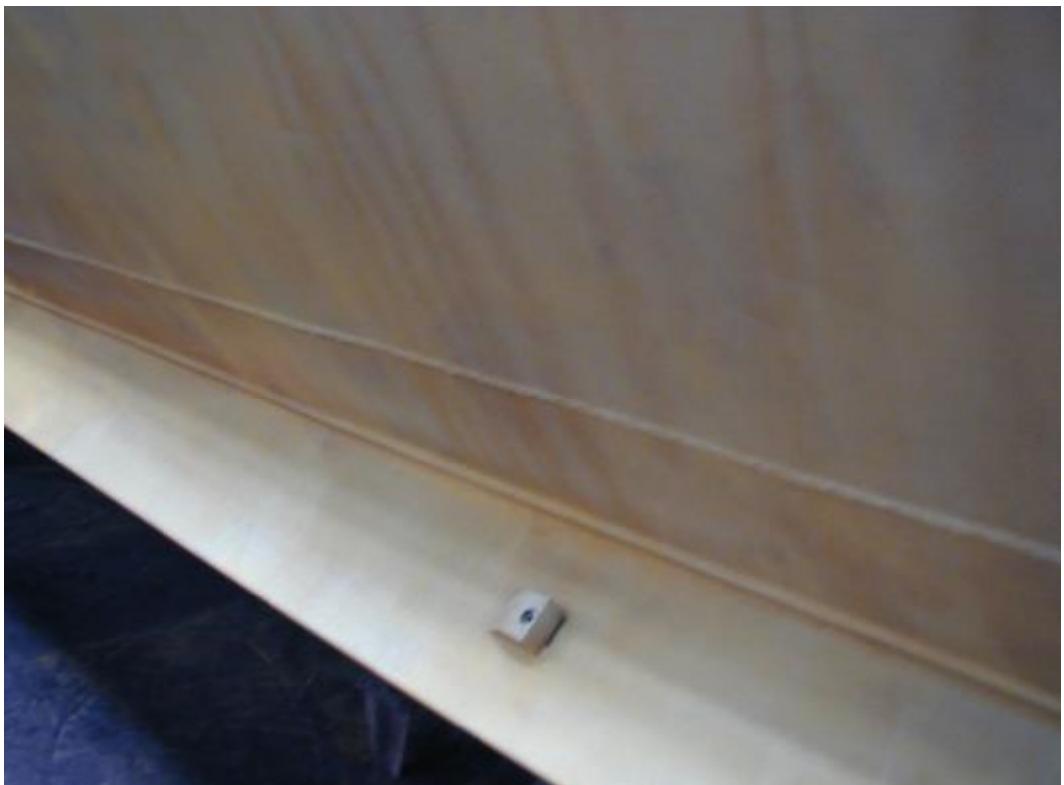
Photo 4. LAURA KOSAN underwater part – surface preparation.

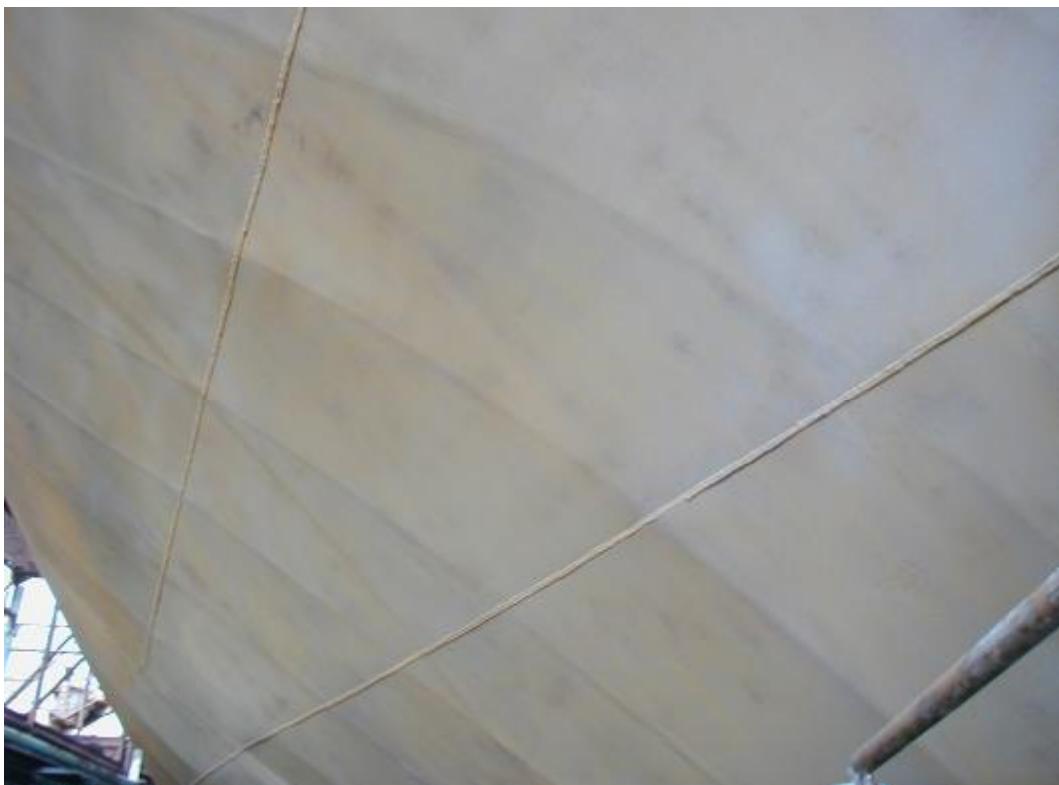
Photo 5. LAURA KOSAN underwater part – surface preparation.

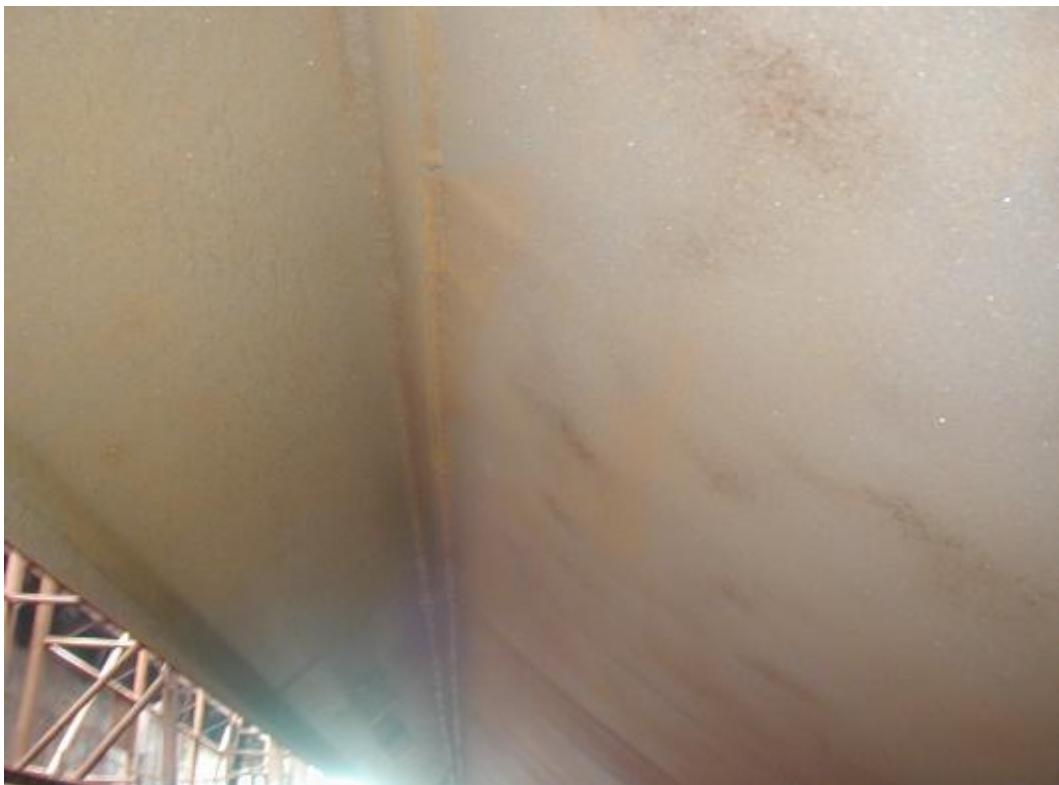
Photo 6. LAURA KOSAN underwater part – surface preparation.

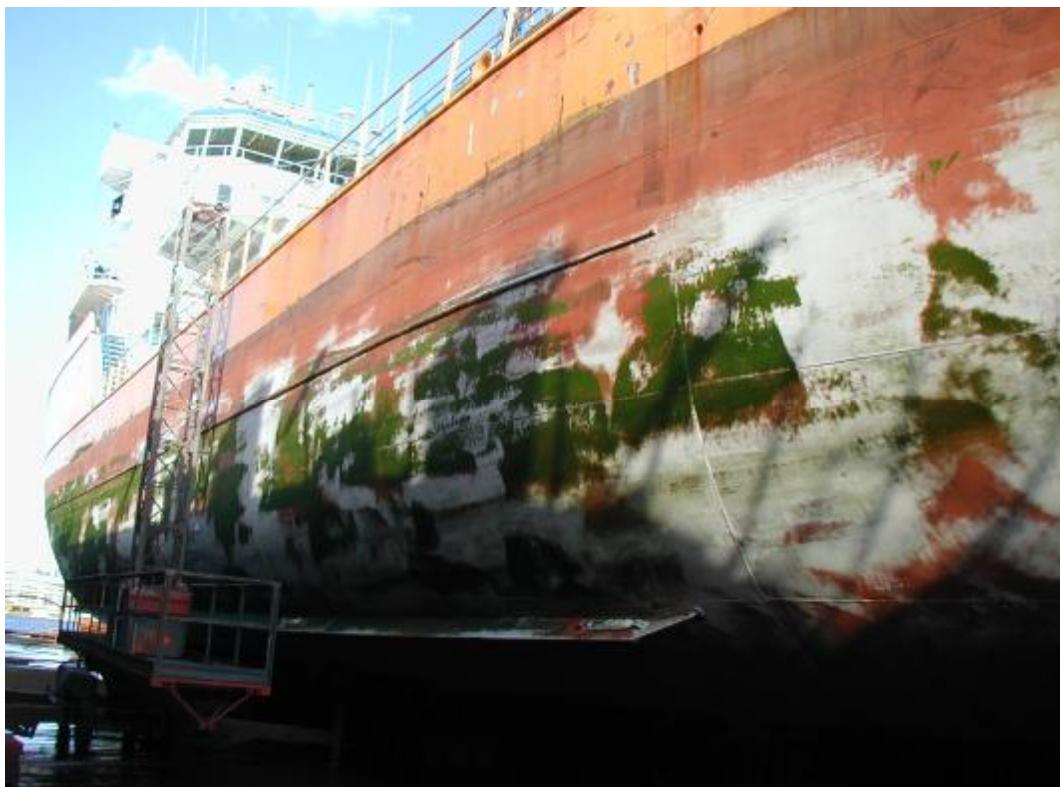
Photo 7. LINDA KOSAN – initial condition.

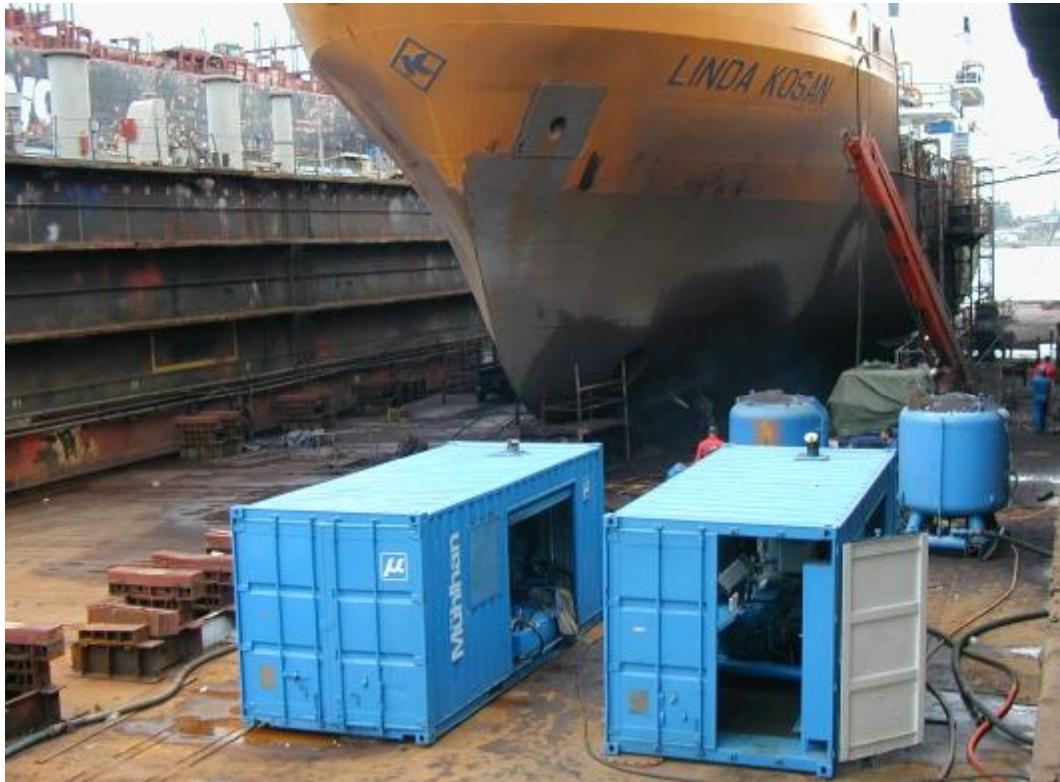
Photo 8. LINDA KOSAN underwater part – surface preparation.

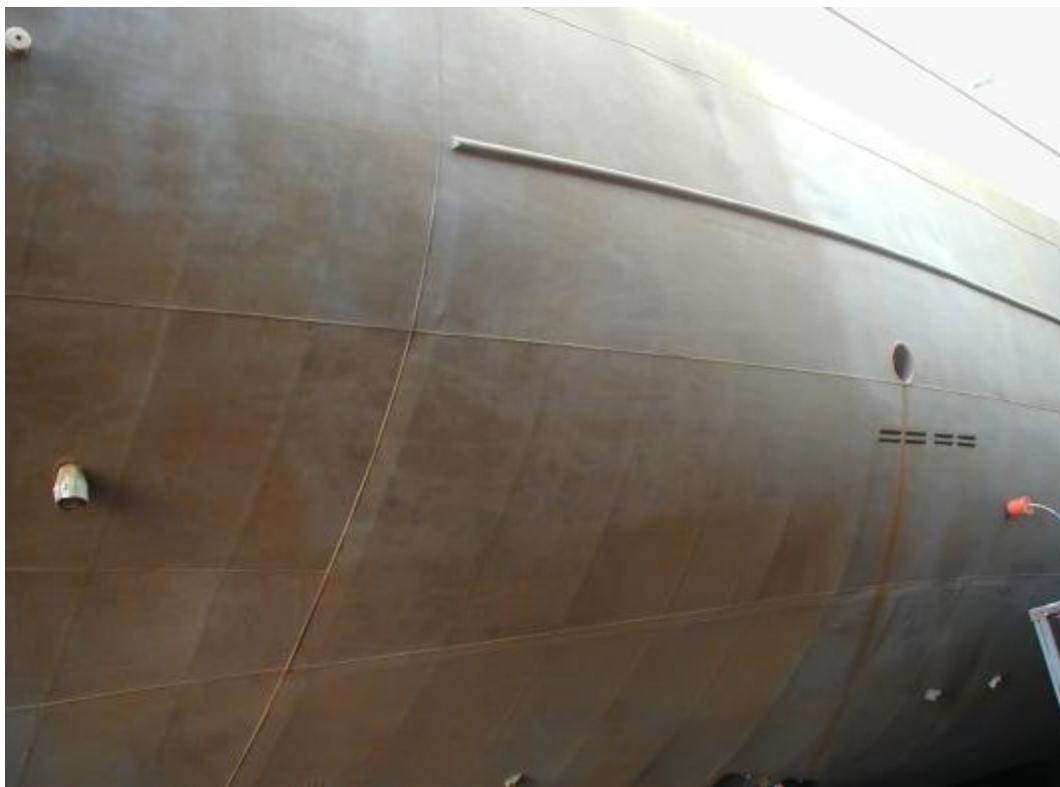
Photo 9. LINDA KOSAN underwater part – surface preparation.

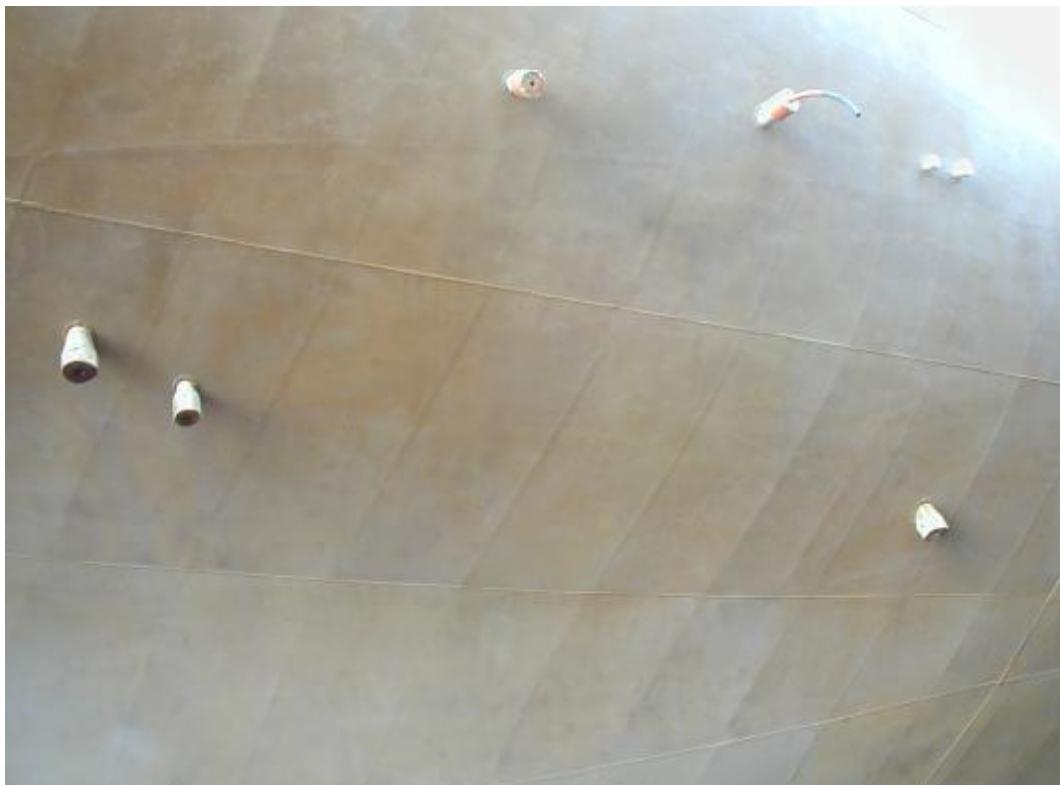
Photo 10. LINDA KOSAN underwater part – surface preparation.

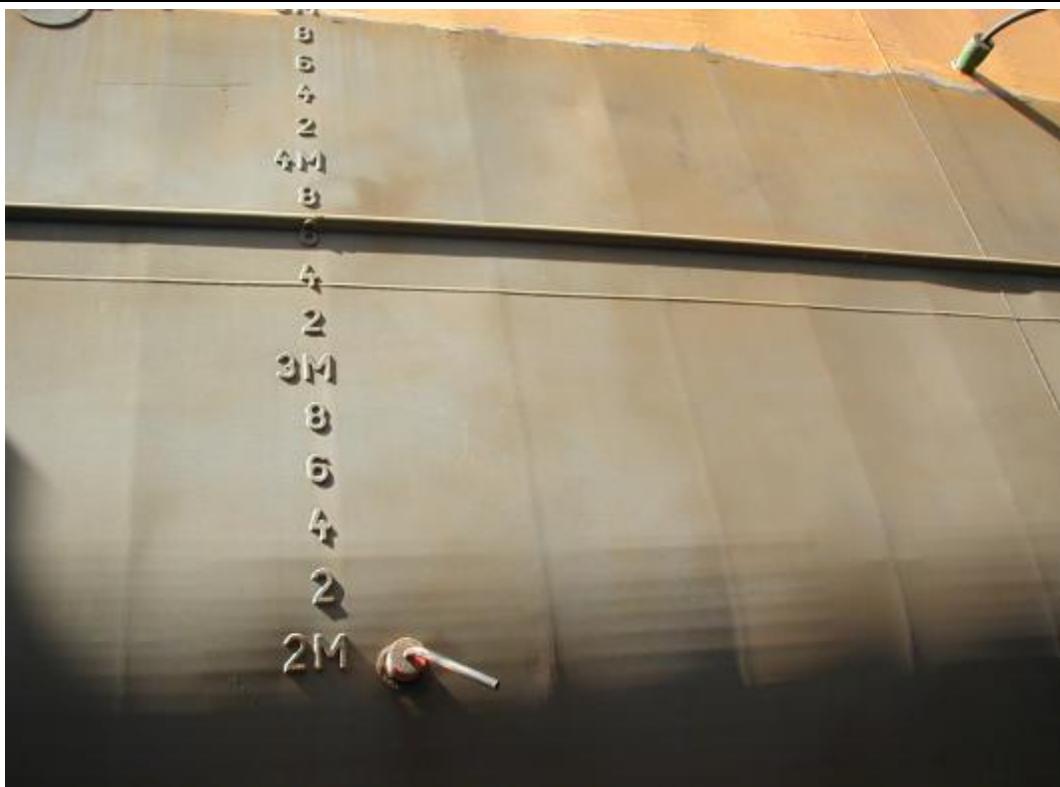
Photo11. LINDA KOSAN underwater part – surface preparation.

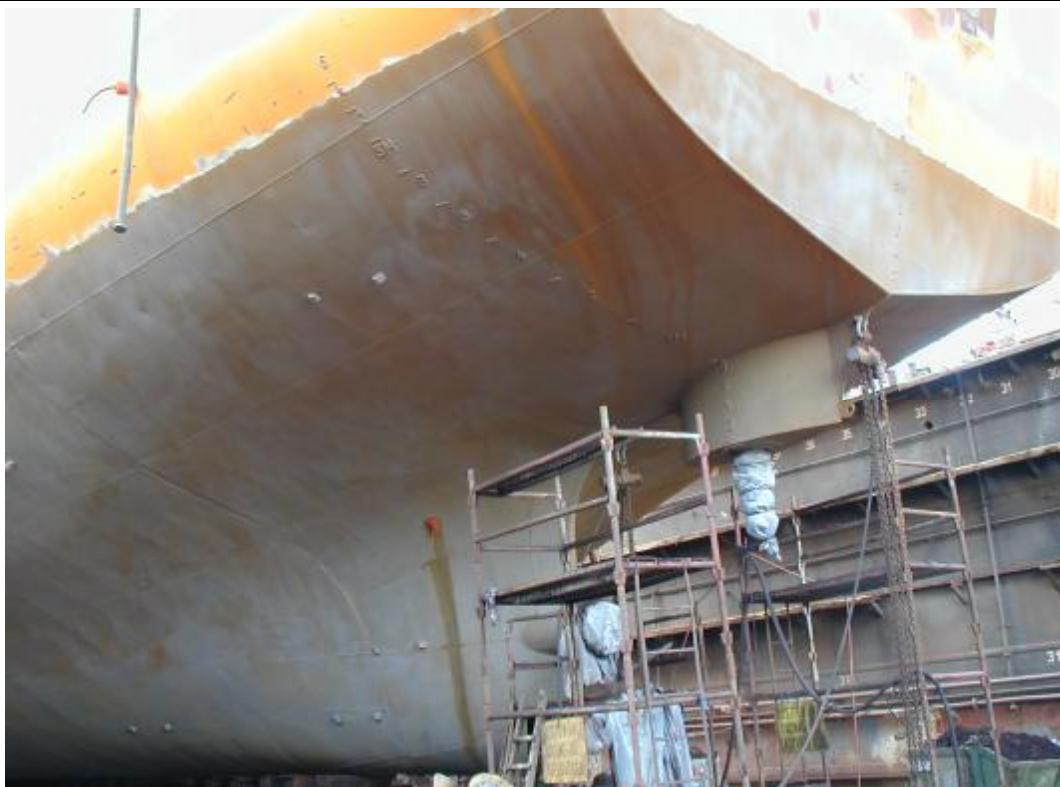
Photo 12. LINDA KOSAN underwater part – surface preparation.

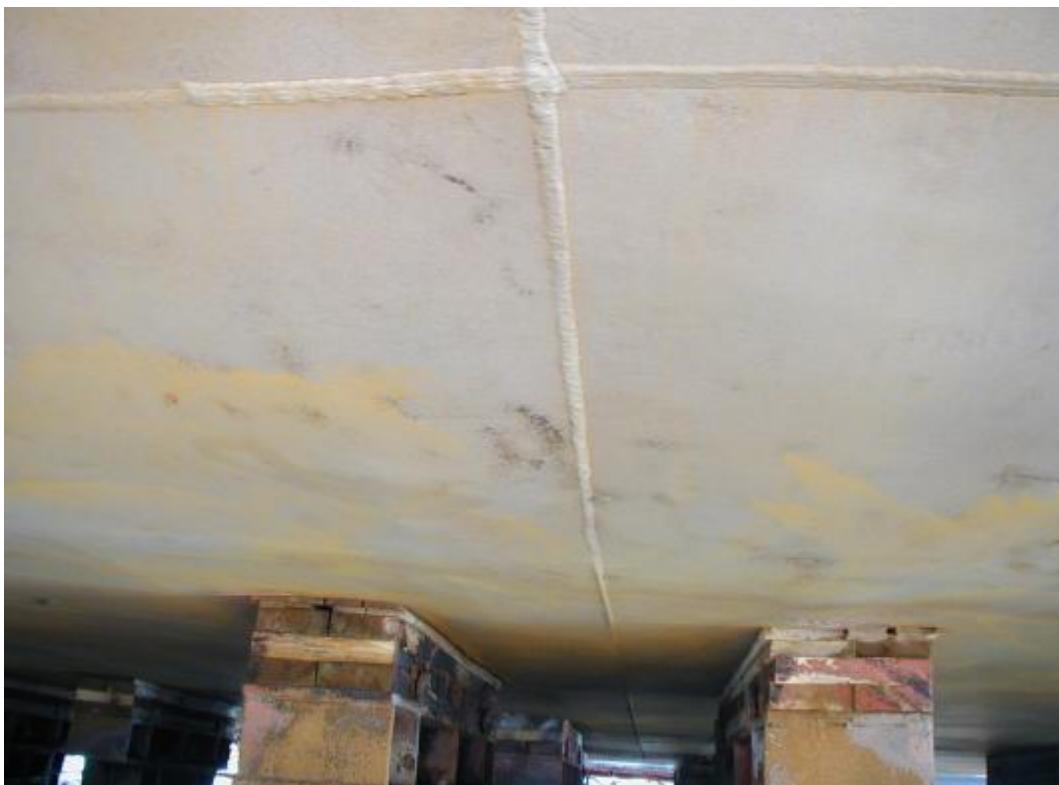
Photo 15. LINDA KOSAN underwater part – surface preparation.

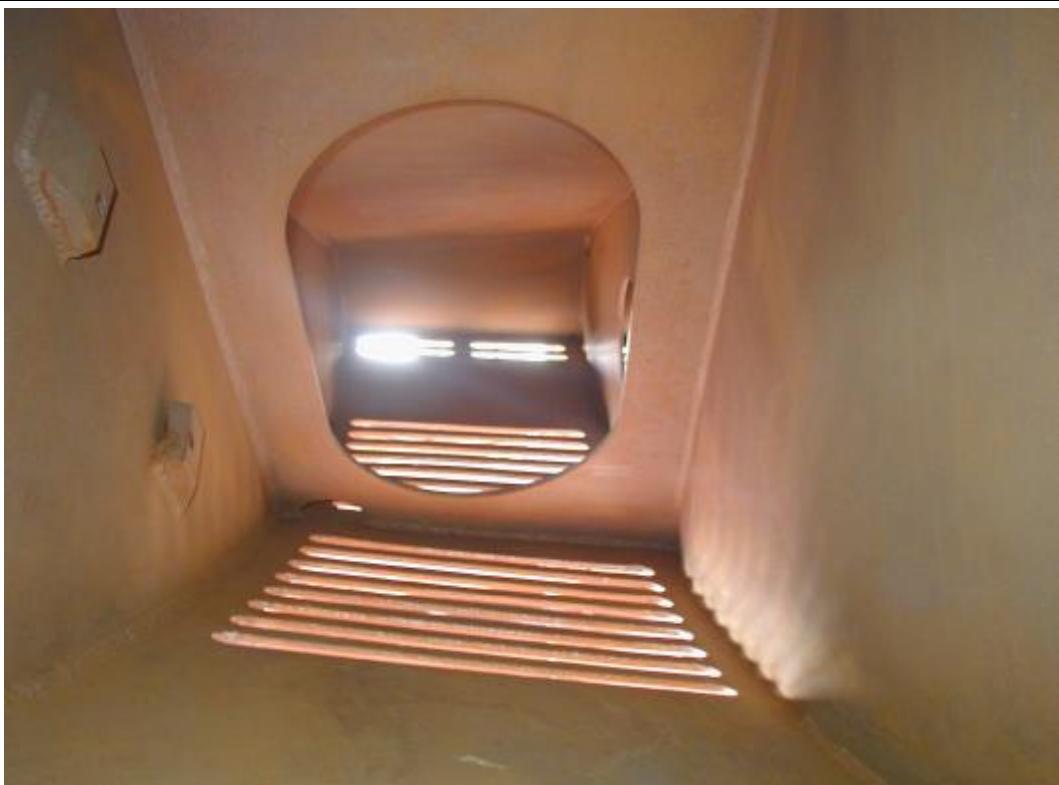
Photo 16. LINDA KOSAN underwater part sea chest – surface preparation.
